Highways 18 and 22 Safety Report

HIGHWAYS 18 AND 22 SAFETY REPORT

**OREGON DEPARTMENT OF
TRANSPORTATION**

September 3, 1999

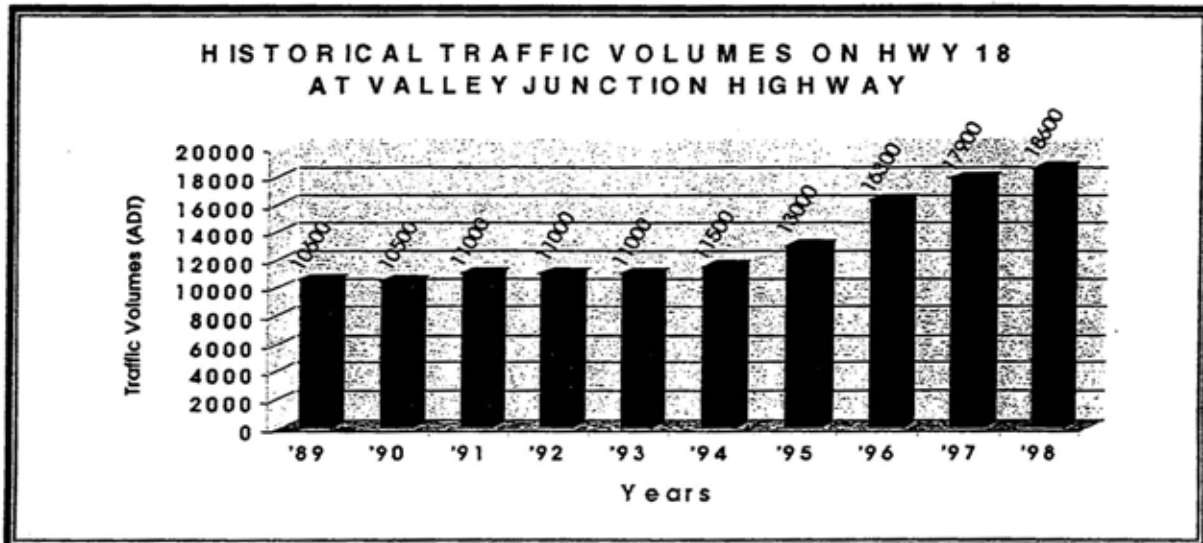
Figure 2
1989 – 1998 Traffic Volumes

*Volumes obtained from ODOT ATR Station 27-001 at MP 23.76

As illustrated in *Figure 2*, Highways 18 and 22 have experienced a 75 percent increase in traffic volumes over the last 10 years. In the past four years alone the traffic volumes have increased 60 percent on these roads. The most notable increase was during the 1995 to 1997 period with the opening or upgrading of several major tourist attractions and retail centers. These include: the Spirit Mountain Casino in Grande Ronde, Chinook Winds Casino in Lincoln City, the Oregon Coast Aquarium in Newport, and the Factory Outlet malls in Lincoln City and McMinnville. Highways 18 and 22 are the primary routes for traffic from Portland and Salem to these attractions and the Oregon Coast.
